Manhole Inspection Summary

Manhole # S31WW_011MH

Location Address: **3100 WYAMN PARK DR**

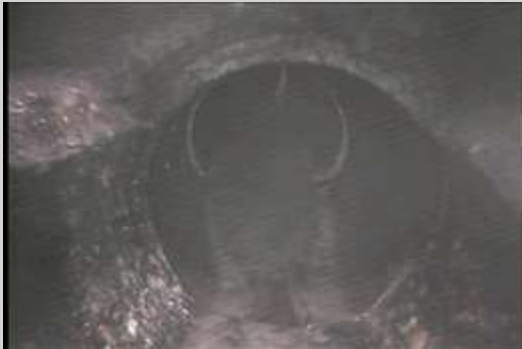
8 in. Circular Gravity Sewer Pipe Out @ 12 O'Clock

Rod and Bar (Angled)

Pipe Material: **Clay** ☐ Pipe Lined

Invert Depth: **10.80** (ft.) Flow Characteristics: **Fast**

Deposits: ☒ None ☐ Mud ☐ Sludge ☐ Debris ☐ Grease

Infiltration: **None**

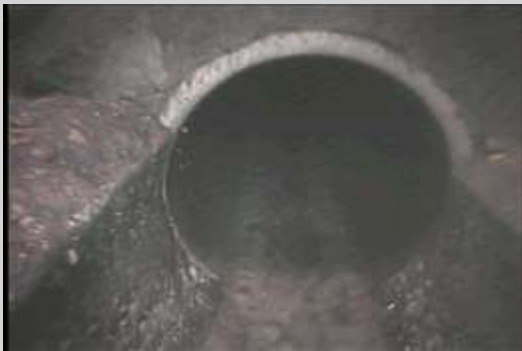
8 in. Circular Gravity Sewer Pipe In @ 7 O'Clock

Rod and Bar (Angled)

Pipe Material: **Clay** ☐ Pipe Lined

Infiltration: **None**
